DILAPIDATION REPORT

Commissioned by
RICHARD CROOKES CONSTRUCTIONS PTY LTD

Inspection date
22 SEPTEMBER 2021

**1 FAULKNER WAY
EDMONDSON PARK NSW 2174**

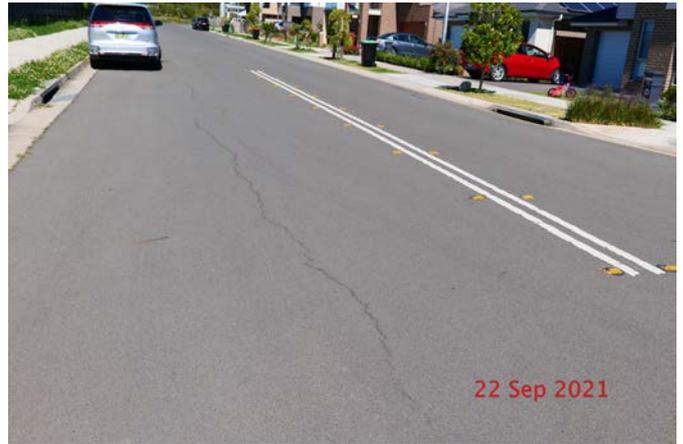
Photo 31.jpg

5.1.3	Multiple longitudinal cracks to mid width of bitumen laneway, between north side of intersection Faulkner Way/Gallipoli Drive to north side of driveway entry of property 49 Faulkner Way	31-32

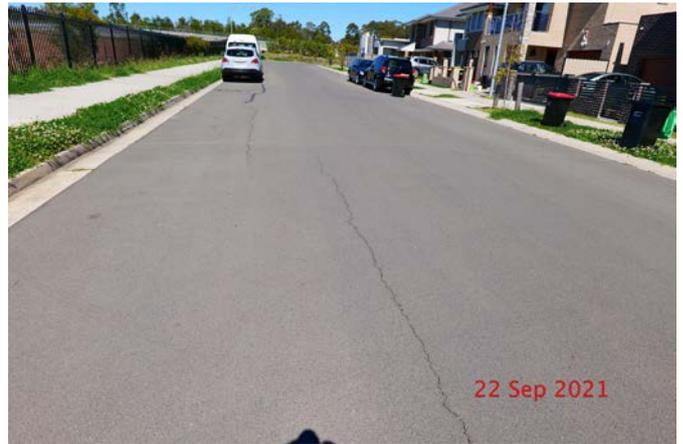
Photo 37.jpg

5.1.7	Multiple gouge marks to bitumen laneway, adjacent concrete gutter, approx. in line with north side of crossing to property 49 Faulkner Way	36
5.1.8	Multiple longitudinal cracks, approx. mid width of bitumen laneway, between mid-width of crossing to property 42 Faulkner Way and south side of crossing to property 36 Faulkner Way	37-39

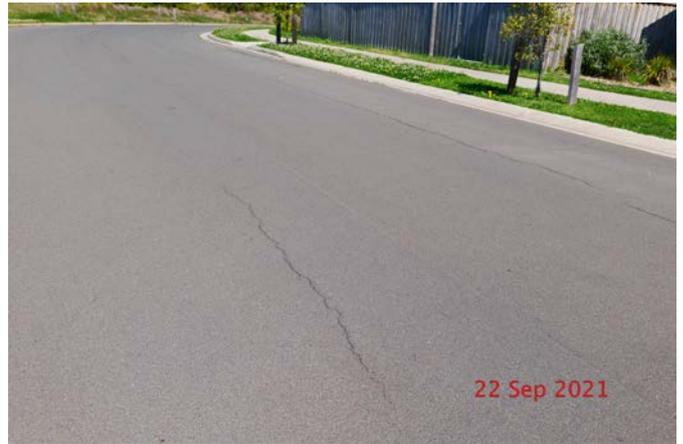
Photo 43.jpg

5.1.11	Longitudinal crack, east side of bitumen laneway, opposite north side of residence of property 34 Faulkner Way	43
5.1.12	Longitudinal crack, west side of bitumen laneway, approx. in line with south side of crossing to property 32 Faulkner Way	44

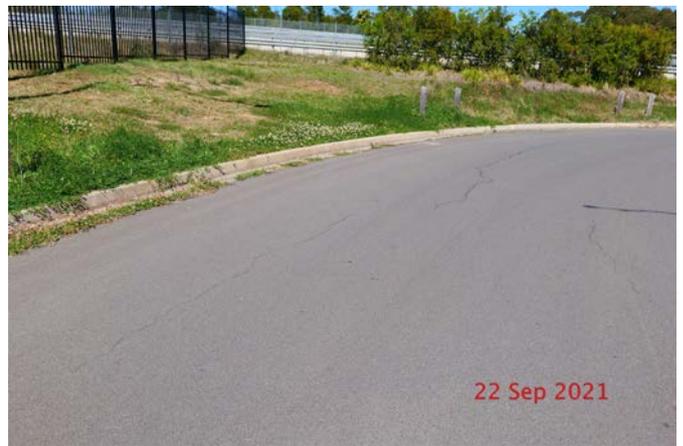
Photo 45.jpg

5.1.13	Multiple cracks to east, mid-width and west side of bitumen laneway, adjacent road curvature at south side of proposed development site, adjacent rail corridor	45-48

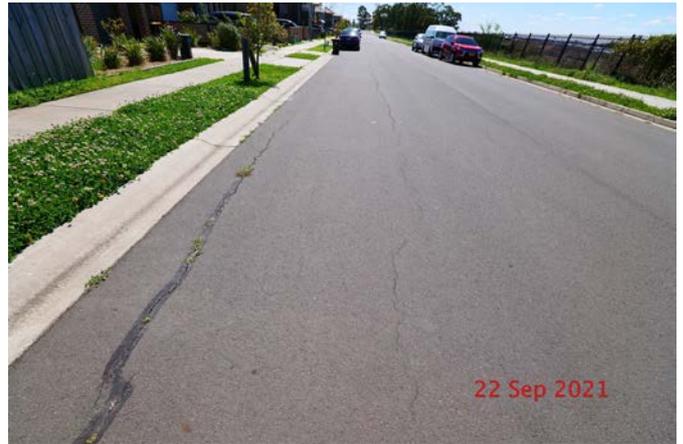
Photo 79.jpg

5.1.16	Multiple longitudinal cracks, mid-width and west side of bitumen laneway, between pedestrian crossing ramp adjacent railway corridor and north side of crossing to property 32 Faulkner Way	79-82

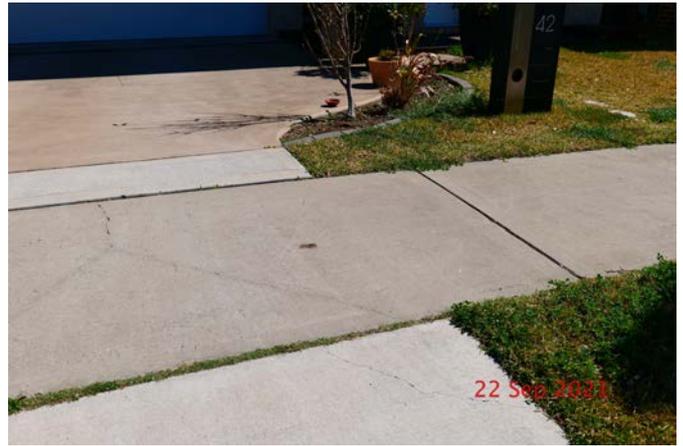
Photo 91.jpg

5.1.25	Multiple cracks to concrete footpath and crossing, adjacent north side of driveway entry to property 42 Faulkner Way	91-92
5.1.26	Damage to west side of concrete footpath panel, adjacent control joint, in line with north side of residence entry to 42 Faulkner Way	93

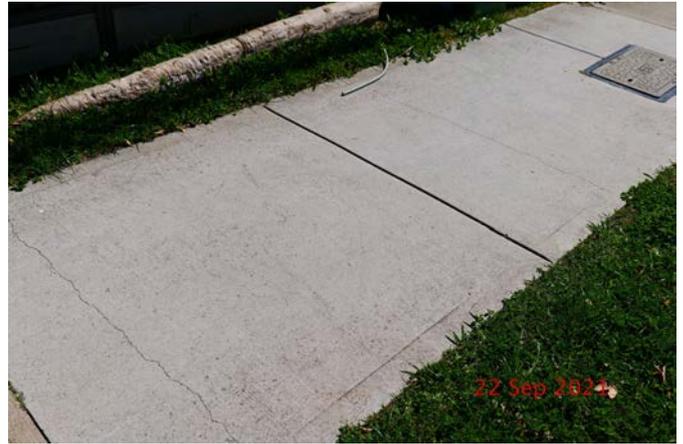
Photo 99.jpg

5.1.30	Gouge marks, west side of bitumen laneway, approx. 3.5m north off intersection Faulkner Way/Gallipoli Drive	98
5.1.31	Crack across concrete footpath, approx. 10m north off intersection Faulkner Way/Gallipoli Drive	99

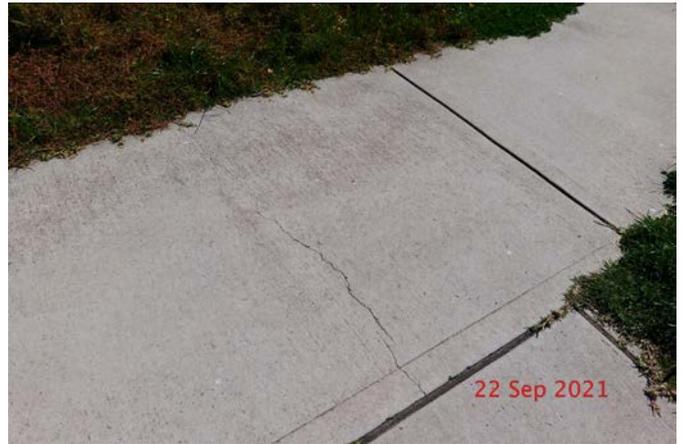
Photo 103.jpg

5.1.34	Crack across concrete footpath, approx. 2.2m north off crossing to property 52 Faulkner Way	103
5.1.35	Crack across concrete footpath, adjacent pedestrian ramp at intersection Faulkner Way/Buchan Avenue	104

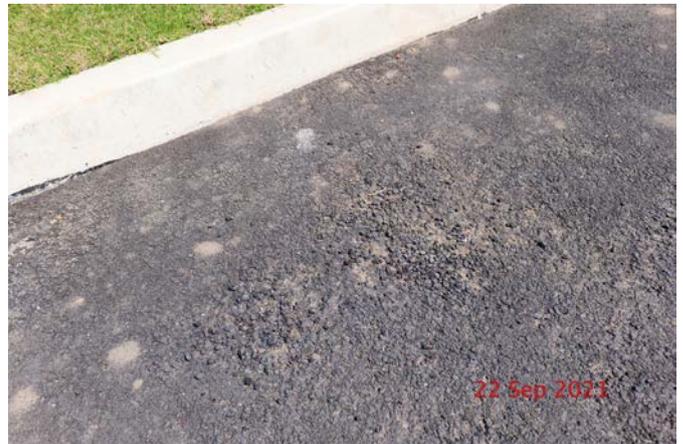
Photo 147.jpg

<i>Item</i>	<i>Description</i>	<i>Photo no.</i>
5.2.4	Surface level degradation and markings to bitumen side lane parking area, adjacent east side of light pole 966498 (typical)	147-148

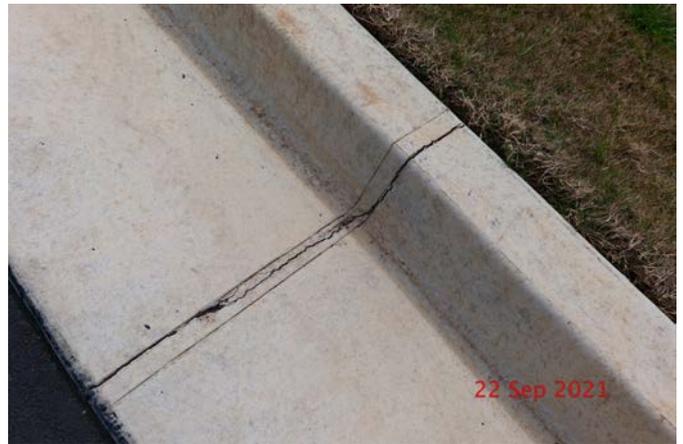
Photo 189.jpg

5.2.7	Crack across concrete kerb and gutter, adjacent control joint, approx. 5m east off stormwater drain, stormwater drain nearest light pole 966500 on opposite side of road	189

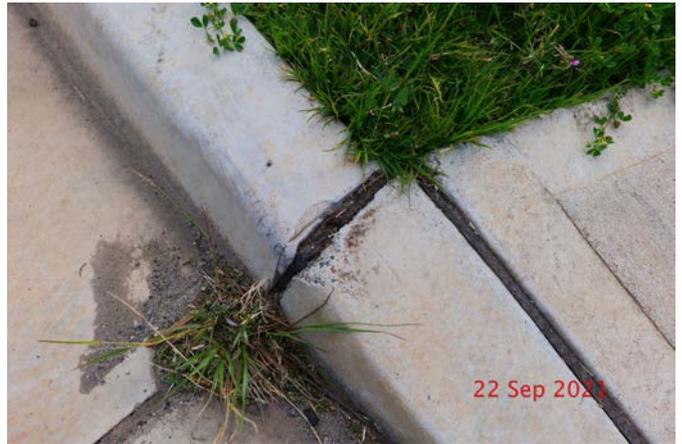
Photo 193.jpg

5.2.11	Crack to concrete kerb and gutter, adjacent control joint (typical), mid-distance between light pole No's 966500 and 966499 to intersection Buchan Avenue/Bezentine Ridge Road	193

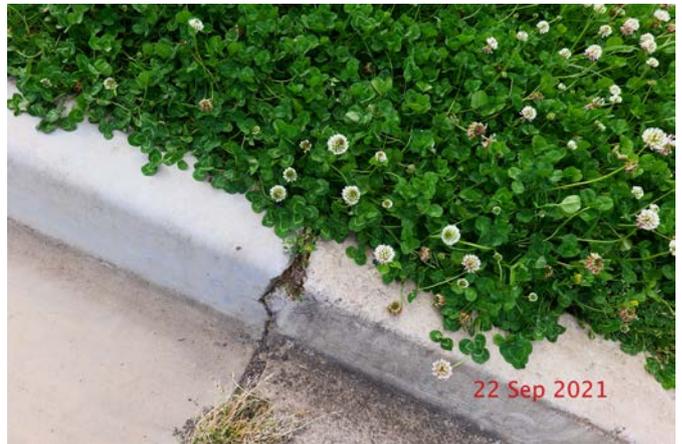
Photo 195.jpg

5.2.13	Multiple scrape and gouge marks, mid-width of bitumen laneway, adjacent east side of intersection Buchan Avenue/Bezentine Ridge Road	195
5.2.14	Damage to concrete kerb and gutter, approx. 7m east off intersection Buchan Avenue/Bezentine Ridge Road	196

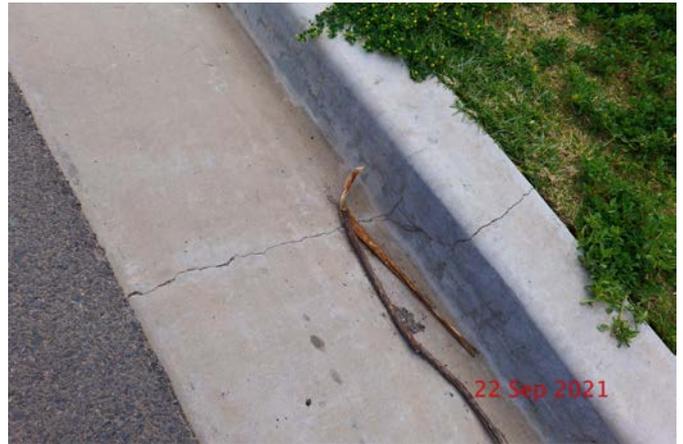
Photo 199.jpg

5.2.17	Damage to concrete gutter, adjacent bitumen laneway, approx. 14.5m east off intersection Buchan Avenue/Faulkner Way	199
5.2.18	Crack across concrete kerb and gutter with fretting along same, approx. 14.5m east off intersection Buchan Avenue/Faulkner Way	200

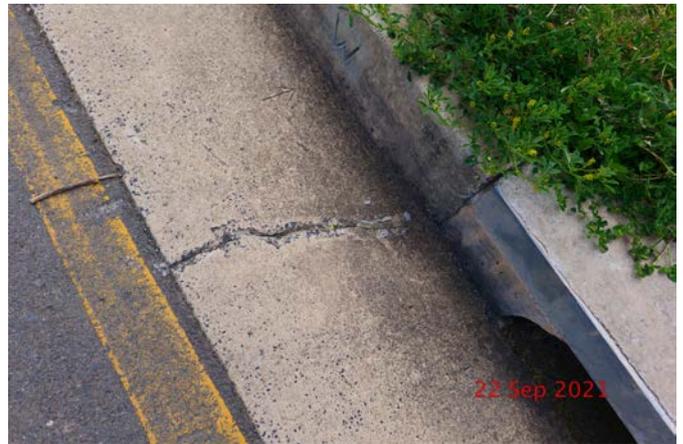
Photo 201.jpg

5.2.19	Crack across concrete gutter, approx. 4m east off drain, nearest intersection Buchan Avenue/Faulkner Way	201
5.2.20	Crack across concrete gutter with damage along same, adjacent west side of drain, adjacent east side of pedestrian ramp, adjacent intersection Buchan Avenue/Faulkner Way	202
