DILAPIDATION REPORT

Commissioned by
RICHARD CROOKES CONSTRUCTIONS PTY LTD

Inspection date
22 SEPTEMBER 2021

**1 FAULKNER WAY
EDMONDSON PARK NSW 2174**

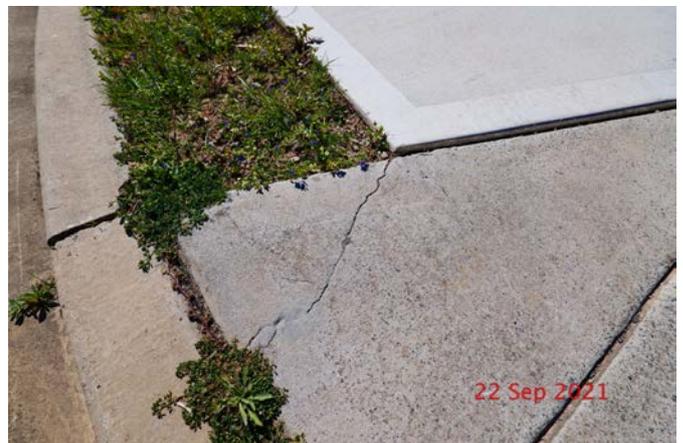
Photo 30.jpg

5.1.2	Crack with fretting along same, across northwest corner of concrete ramp crossing, adjacent kerb and gutter, approx. 4.5m south off intersection Faulkner Way/Buchan Avenue	30

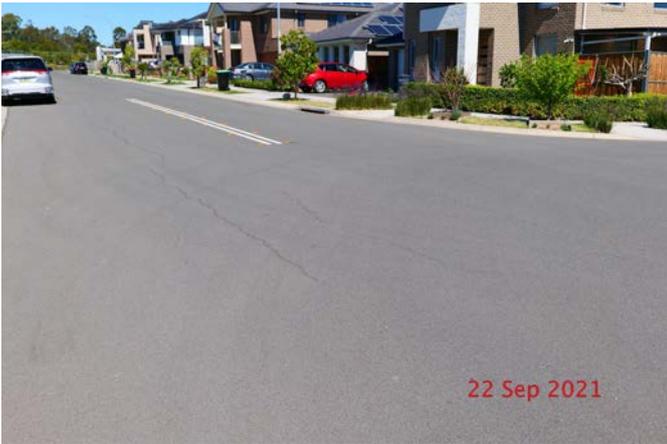
Photo 31.jpg

5.1.3	Multiple longitudinal cracks to mid width of bitumen laneway, between north side of intersection Faulkner Way/Gallipoli Drive to north side of driveway entry of property 49 Faulkner Way	31-32

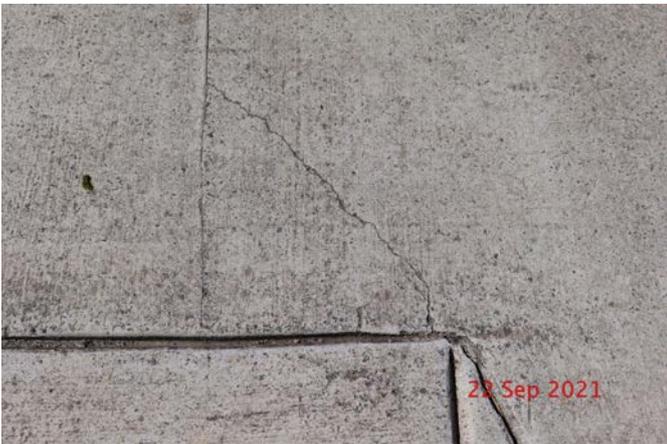
Photo 33.jpg

5.1.4	Crack across west side of concrete footpath, adjacent southeast corner of pedestrian ramp, adjacent south side of intersection Faulkner Way/Gallipoli Drive	33

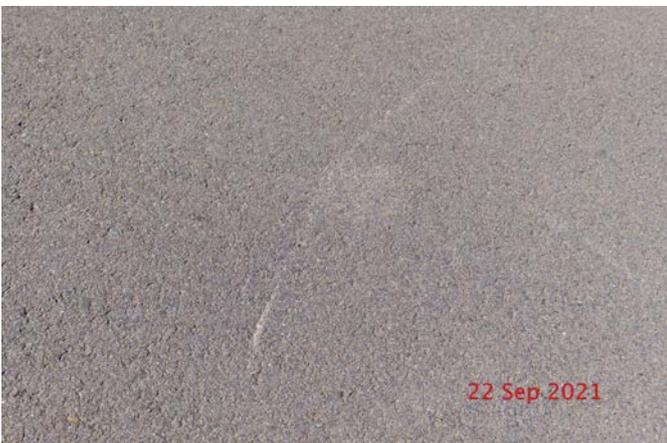
Photo 35.jpg

5.1.5	Multiple longitudinal cracks, mid width of bitumen laneway, adjacent north side of property 46 Faulkner Way	34
5.1.6	Scrape mark, east side of bitumen driveway, approx. in line with north side of crossing to property 46 Faulkner Way	35
